PROJECT	Rodgers Creek Estuary Enhancement Project, West Vancouver, B.C.
DWG. No.	5595-D-15.1

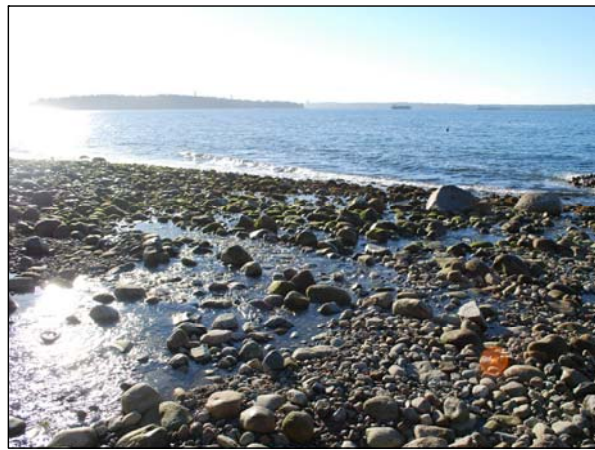
Image 1. Before construction. Intertidal shoreline fronting Rodgers Creek with no defined channel to provide lower tide access for salmon to the creek.

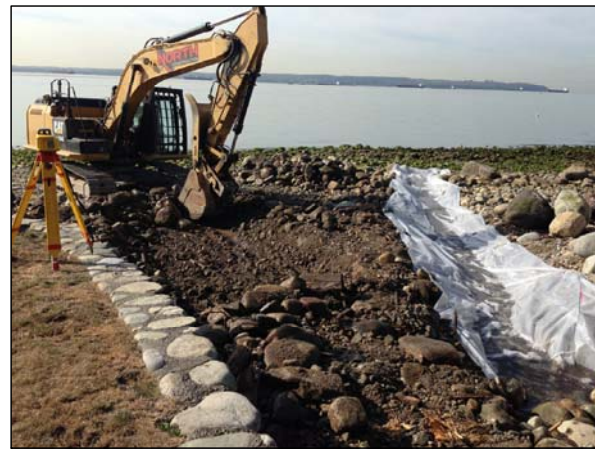
Image 2. Temporary redirection of creek flow and initial channel excavation.

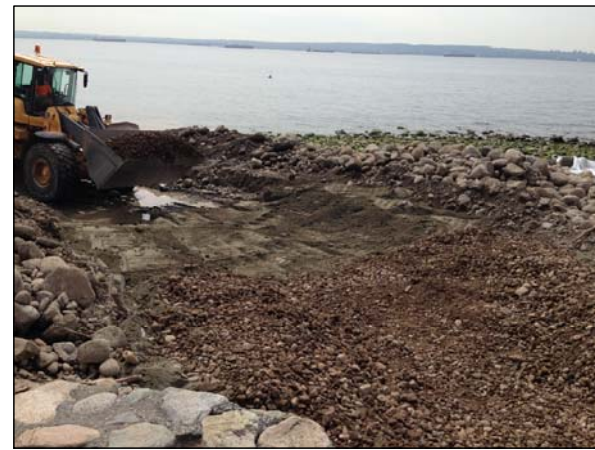
Image 3. Placement of clay/till sealing layer and 15cm minus filter rock.

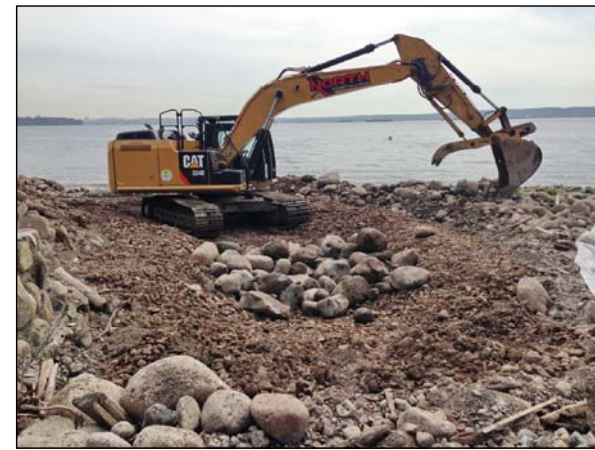
Image 4. Placement of stream armour rock to help prevent channel erosion by creek flow and waves.

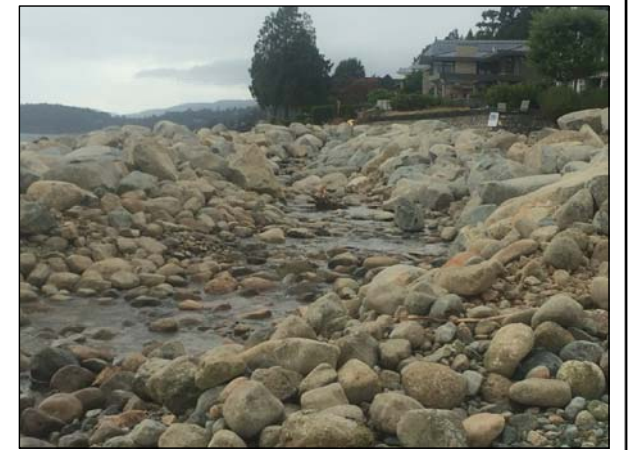
Image 5. Completed base of channel ready for creek complexing.

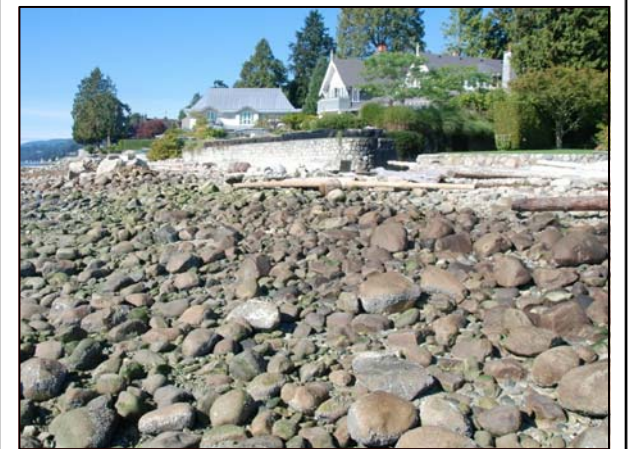
Image 6. Before Rodgers Creek estuary enhancement.

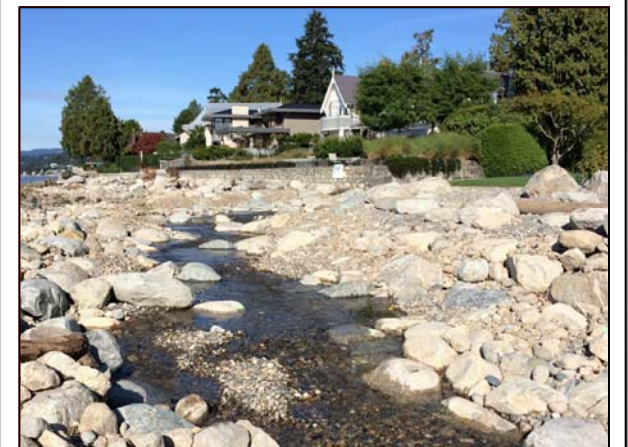
Image 7. After Rodgers Creek estuary enhancement. Note addition of large boulders and stream complexing when compared to Image 5 above.
